U.S. CONSUMER PRODUCT SAFETY COMMISSION
WASHINGTON, D.C. 20207

Re: FOIA Request S-712020: Information concerning Lennox Pulse Furnaces

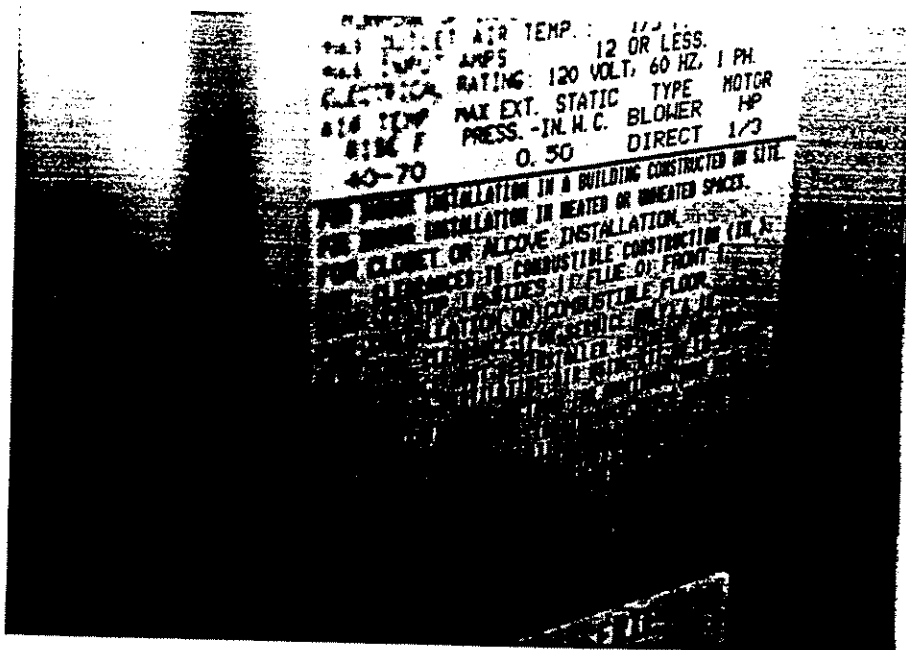
20 & 21 AGA Certification on furnace.

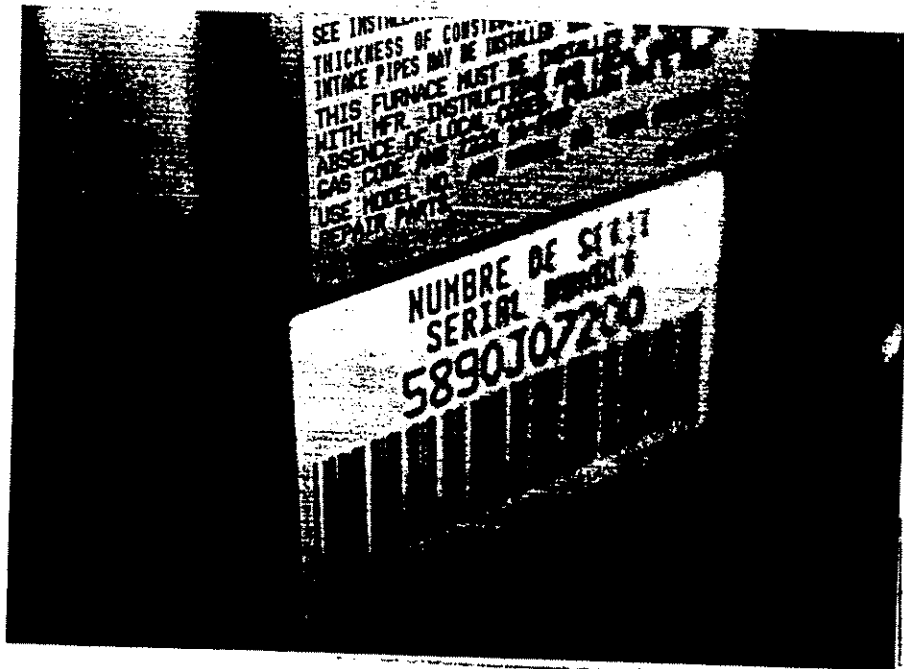
22. Serial number on unit.
