USES OF THE BOREHOLE CAMERA IN HYDROLOGIC INVESTIGATIONS RELATED TO COAL MINING¹

Jay W. Hawkins² and Robert S. Evans

Abstract. Use of a borehole camera in a hydrologic investigation, can yield information that may not be otherwise obtainable. The camera permits confirmation of stratigraphy, fracture and bedding plane separation locations, ground water inflow zones, fracture accentuation due to mine subsidence, and other features. A borehole camera also permits viewing of well bore features that otherwise may be unknown to exist, such as the conditions of the well bore, casing, and pumping system, historic water levels indicated by staining or corrosion, presence or absence of bacterial growths, existence of other organisms, the presence of foreign objects, and influx of gases.

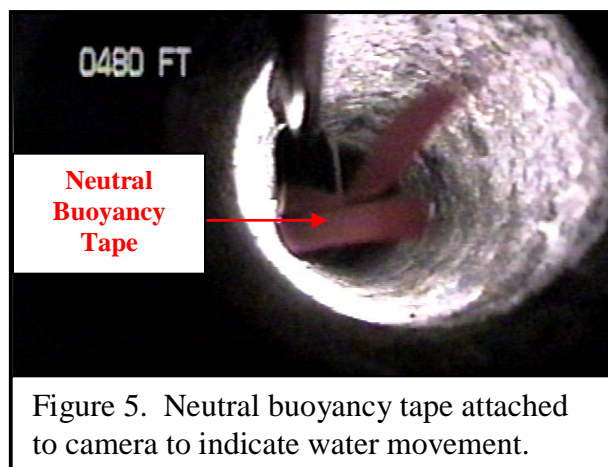
The borehole camera by itself may not be able to note inflow points below the water level, unless there is some variation in the color or clarity of the inflowing water. Therefore, a neutral-buoyancy tape (Fig. 5) was attached to the camera to identify water movement within the well bore, which indicates inflow points and a relative indication of the rate of flow. As

Figure 5. Neutral buoyancy tape attached to camera to indicate water movement.
