## Early 20th-Century Building Materials: Siding and Roofing

*Richa Wilson, Intermountain Regional Architectural Historian  
Kathleen Snodgrass, Project Leader*

This tech tip is the fourth in a series about innovative building materials developed in the first half of the 20th century and commonly incorporated into Forest Service buildings. The series will help you identify materials by describing their histories, manufacture, and physical characteristics. This series also addresses common problems and provides guidance on maintenance, repair, and replacement.

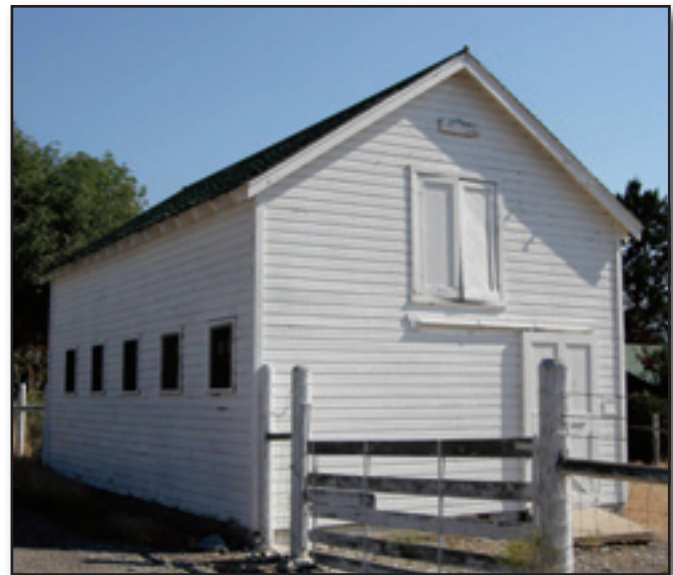
Figure 1—Following national trends, the Forest Service often used wood siding with a variety of profiles on frame buildings in the early 20th century. The drop siding on this barn was one of the most popular choices. The barn was built in 1933 at the Salmon Ranger Station in Salmon, ID (Salmon-Challis National Forest, Intermountain Region).

availability of wood building materials, greatly influenced the exterior appearance of the agency’s first administrative and recreation facilities. Roofs were covered with wood shingles or shakes. Many early Forest Service buildings were constructed from logs. Wood siding with a variety of profiles was the usual cladding on buildings constructed with wood frames (figure 1).

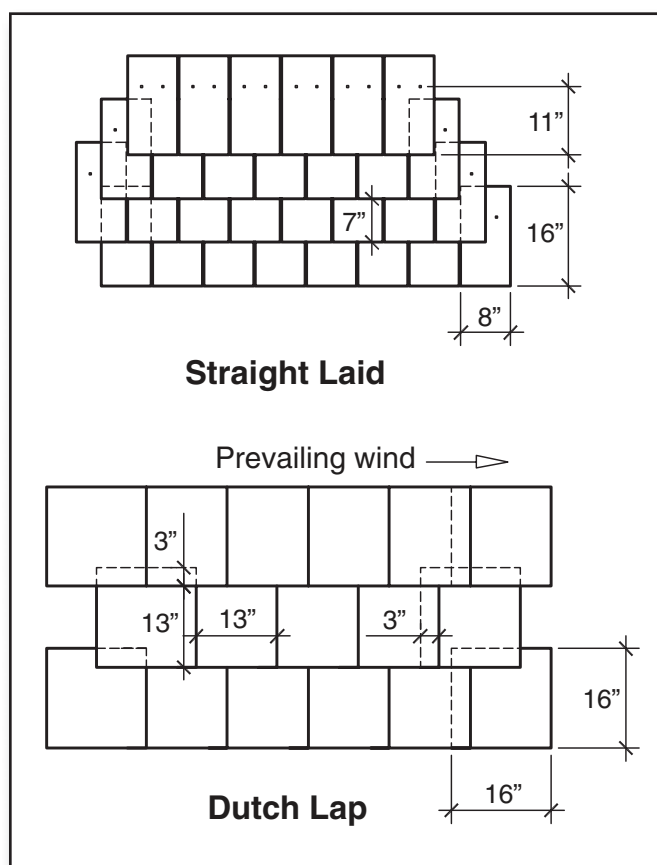
Figure 2—This drawing shows typical sizes, shapes, and installation for American method asphalt shingle roofing.

- American method or "straight" shingles of the 1920s and 1930s were square or rectangular. The shingles were installed to overlap the course below. They could be straight laid, abutting adjacent shingles, or Dutch lap, overlapping adjacent shingles (figure 2).

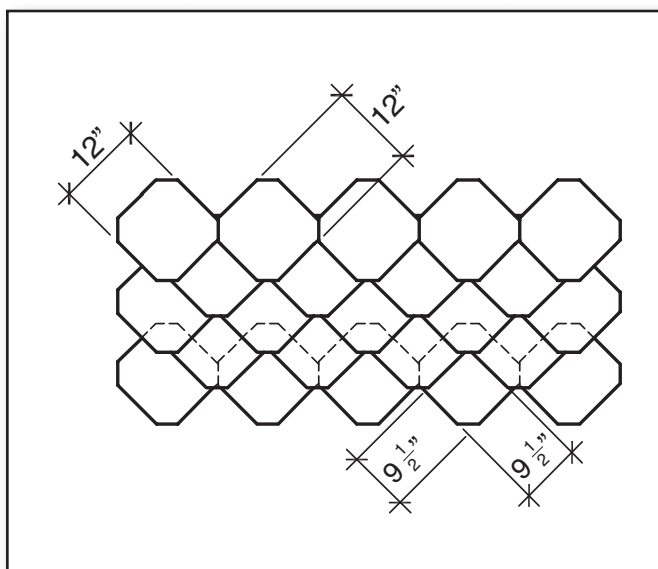
Figure 3—This drawing shows typical sizes, shapes, and installation for French method asphalt shingles.

- French method shingles are shaped like diamonds or hexagons in an attempt to imitate slate roofs of French chateaux. Historically, they were so large (12 by 12 inches and 16 by 16 inches were standard sizes) that they required storm anchors (hooks to hold the edges down during high winds). Because they had little overlap on their edges, French method shingles provided only one layer of roofing. This was acceptable when they were installed over existing roofing, but not in new construction as the French method provided only minimal protection of the roof deck (figure 3).

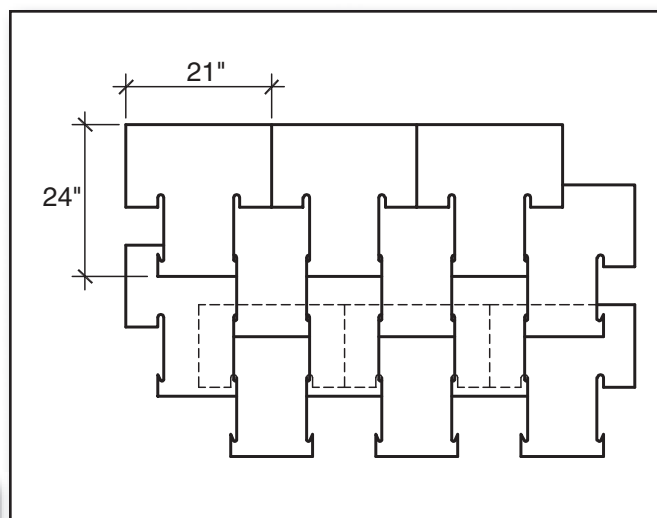
Figure 4—This drawing shows typical sizes, shapes, and installation for interlocking asphalt shingles.

- Interlocking shingles, whether installed in strips or as individual shingles, have high wind resistance and protect the roof decking better than other types. They were available by the late 1920s and were popular during the 1930s and 1940s. The complex shapes had ears, catches, and slits that interconnected with the shingle course below to create a basket weave pattern. Interlocking shingles worked well on the rolled eaves of cottage style houses (1930s and 1940s), where they evoked thatched roofs (figure 4).

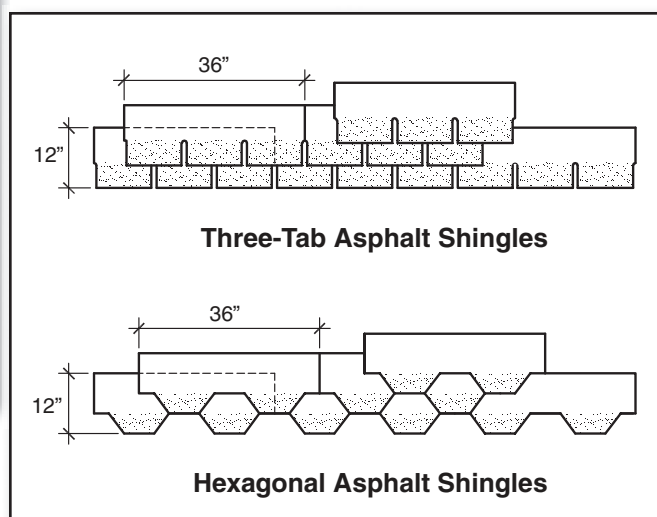
Figure 5—This drawing shows typical sizes, shapes, and installation for tab-style asphalt shingles.

Individual shingles fell out of favor as more companies produced strip shingles, with or without tabs. Tab shingles have cutouts that minimize buckling and mimic the appearance of individual shingles. By 1935, most major manufacturers were producing 12- by 36-inch tab shingles (figure 5) that looked similar to those manufactured today.

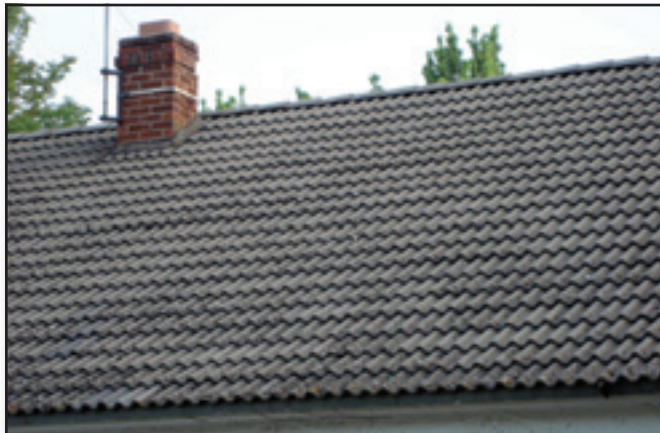
Figure 6—Asbestos-cement roofing tiles were popular on period revival styles such as the Mission and Spanish Eclectic styles, which were most common in the Southwest and Florida.

Like their asphalt counterparts, asbestos-cement shingles were characterized by a variety of shapes (square, rectangular, diamond, chamfered, scalloped, and ogee) and method of installation (American, French, or interlocking). Asbestos-cement roofing tiles shaped to imitate clay tiles found on French and Spanish-style buildings were also produced (figure 6).

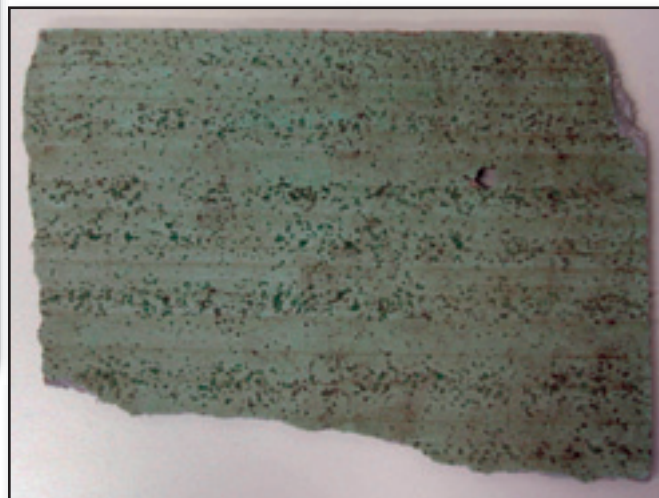
Figure 8—The pigment granules pressed into the surface during manufacturing are clearly visible on this broken piece of asbestos siding.

White, gray-pink, and gray-green were the most common of the limited colors available for asbestos-cement siding. In the 1940s, speckled patterns were produced by pressing granules of pigment into the surface (figures 8 and 9). Manufacturers began offering deeper hues of brown, green, and coral during the booming 1950s housing market. Despite the available colors—or perhaps because of them—many structures with asbestos-cement siding were eventually painted.

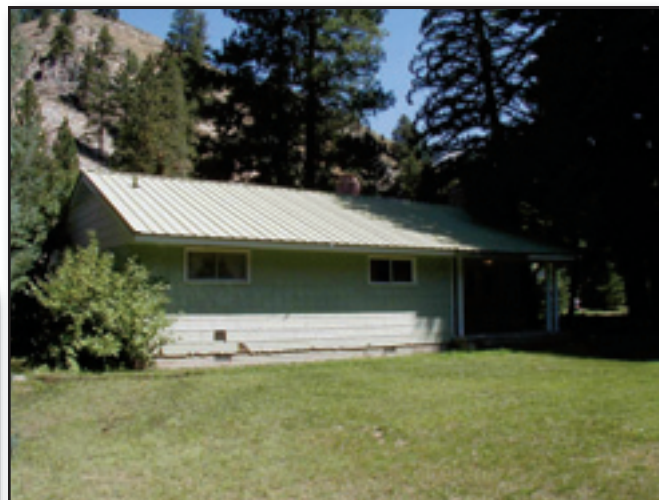
Figure 9—The broken piece of siding shown in figure 8 is from this 1957 house at the Shake Creek Guard Station on the Sawtooth National Forest, ID (Intermountain Region).

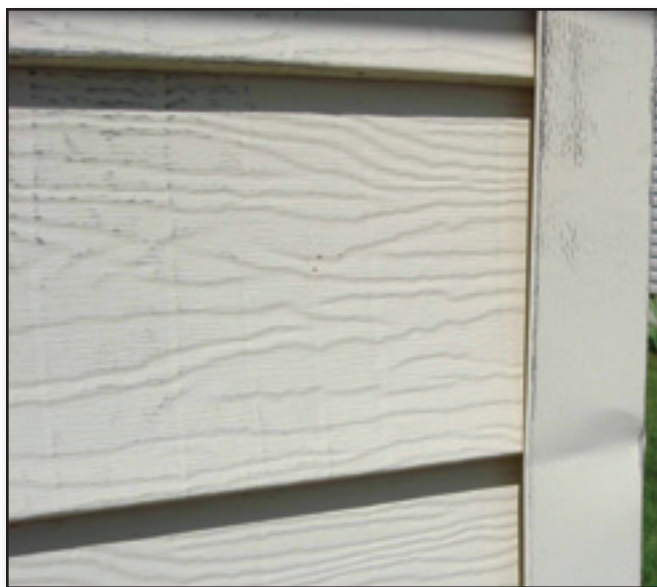
Figure 10—The corner of this house in Soda Springs, ID (Caribou-Targhee National Forest, Intermountain Region), is covered in steel siding that has been battered and bent over the years.

Vinyl and metal siding are similar in appearance, but sound very different when lightly tapped. Once you have identified the siding as metal, use a magnet to determine whether it is aluminum or steel. Aluminum siding is not magnetic. Steel siding (figure 10) is magnetic.

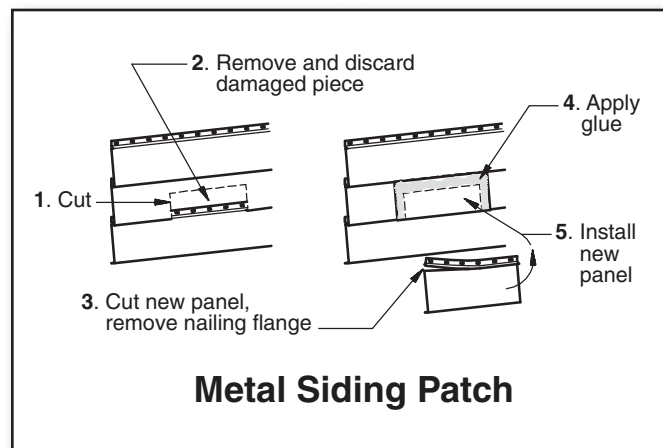
Figure 11—This drawing shows how to patch metal siding using polyurethane caulk or clear silicone sealant to glue the patch in place.

If the damaged area is large, consider patching it with new siding that matches the existing siding (figure 11). Mark vertical lines on either side of the damaged area. Cut across the center between these two lines and down the lines with a utility knife or tin snips. Remove and discard the lower half. Cut a patch panel from the new material so it will overlap the removed section by 2 inches on each side. Cut the nailing flange from the patch. Coat the overlapping area with polyurethane caulk or clear silicone sealant. Press the new panel over the damaged area so that it adheres to the caulk or sealant.
