PRESERVATION Tech Notes

MASONRY NUMBER 4

Non-destructive Evaluation Techniques for Masonry Construction

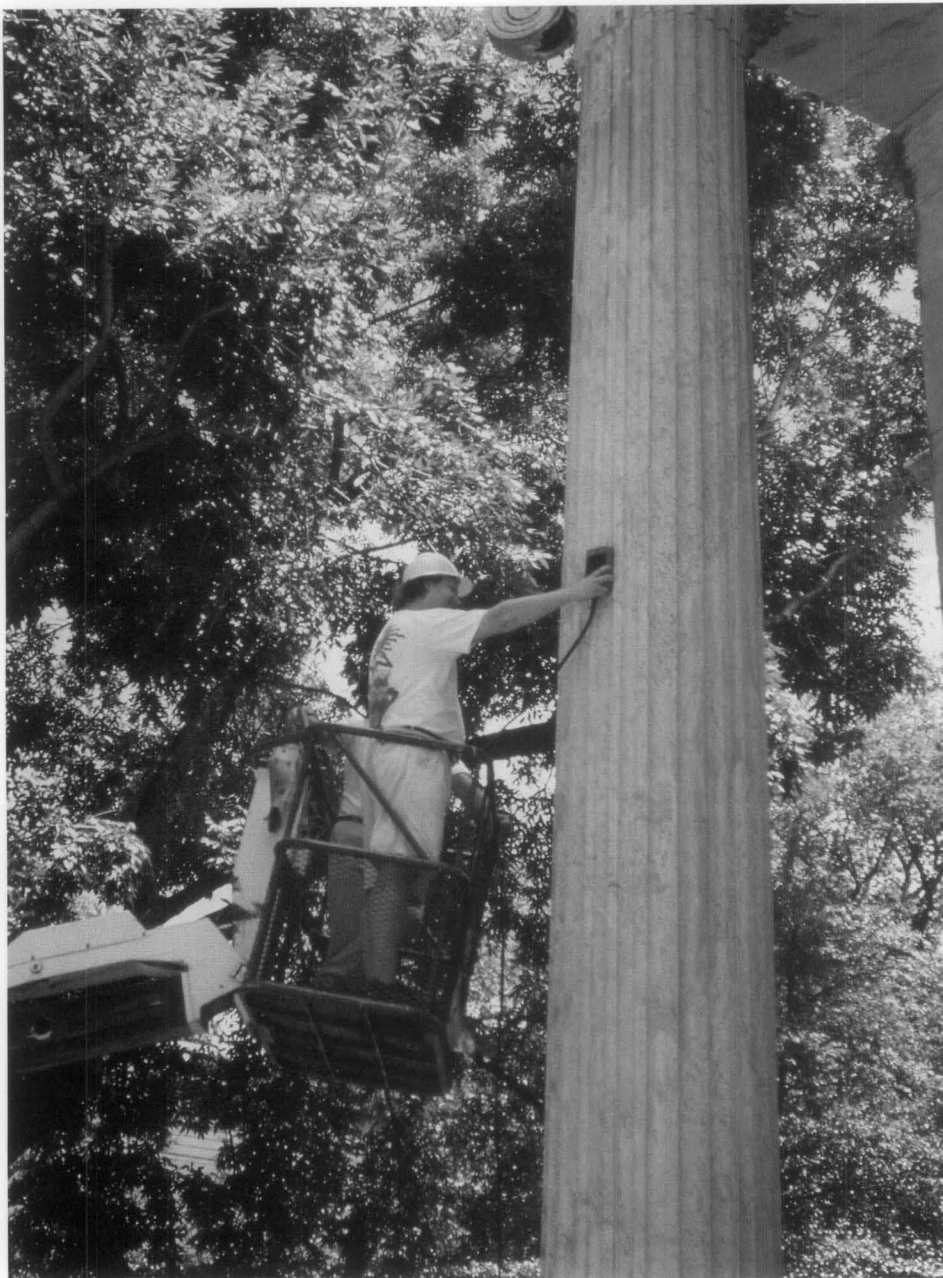
Figure 1. At the New York State Capitol in Albany, New York, non-destructive evaluation techniques were used to determine existing structural conditions and to locate hidden structural elements. Most construction documents had been lost in an early 20th century fire; data collected through non-destructive evaluation served to re-create the structural drawings. Photo: Marie Ennis, P.E.

5 stories tall, with a full basement and attic. Although basement foundation walls up to 16-feet thick support the 200,000 ton building load, the Capitol has suffered significant structural problems since construction. The building load is spread unequally over the foundation, and the site contains layers of local clay mixed with sand and water, which is susceptible to liquefaction. When these conditions were discovered during the initial excavation, the idea of using wood pilings was abandoned and a 3-foot thick unreinforced concrete slab was placed over the excavation to support stepped stone footing for walls and piers.

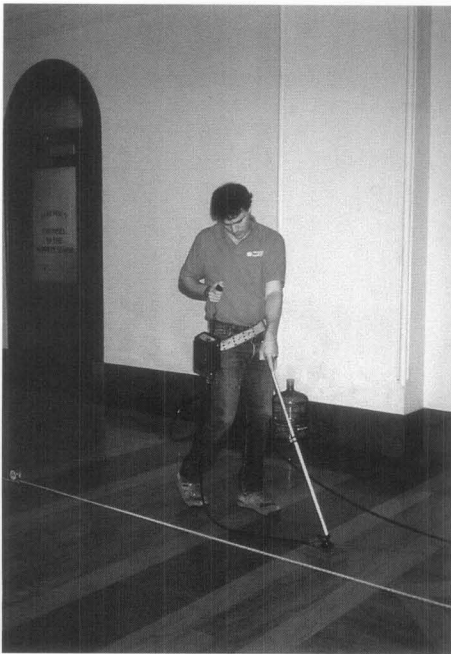
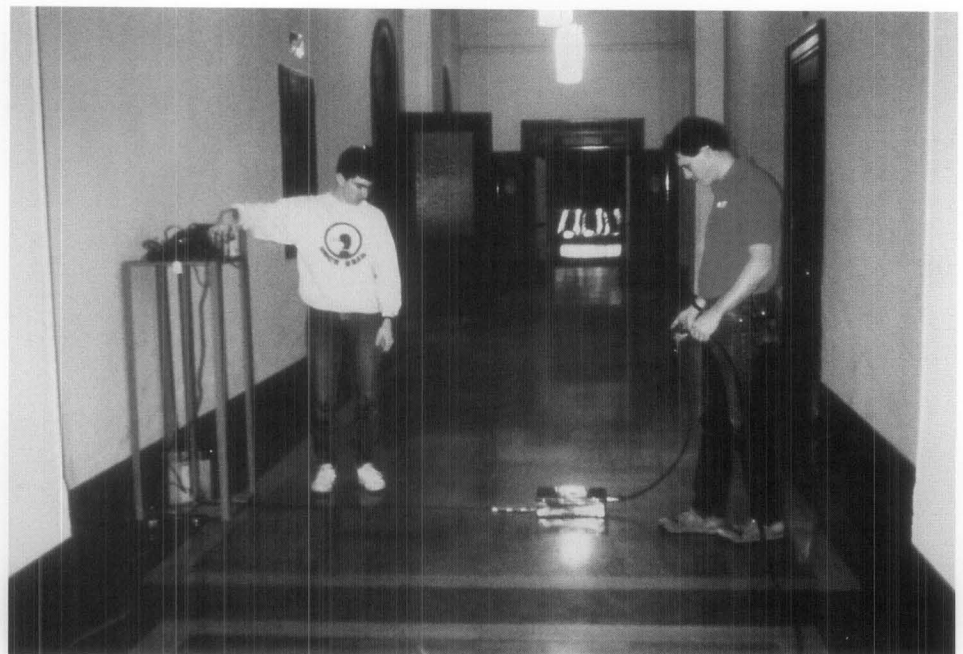
Figure 2. (a) The floor structure is scanned using impulse radar. An operator is shown, pushing the transducer across the floor surface at a constant speed. (b) The transducer is being pulled, by machine, at a constant speed. Photos: Marie Ennis, P.E.

Impulse Radar. For the New York State Capitol project, the radar tests successfully located embedded beams, girders, columns, and metal ties/anchors (see figure 2). The readings enabled the investigators to profile brick arches spanning

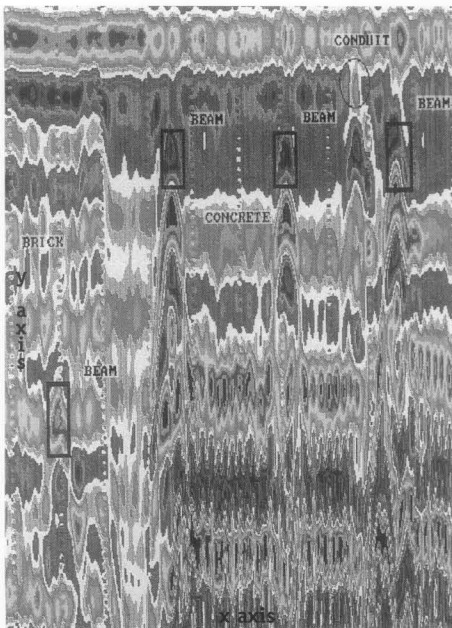
Figure 3. This is the raw output from a radar scan. The beams, brick arches, and concrete slab have been noted. (x-axis= velocity of transducer; y-axis = wave response time.) Photo: U.S. Army Construction Engineering Research Laboratory.

roughly 5 feet between beams, and to locate H-shaped steel columns in masonry walls showing the orientation of the flanges. The tests readily measured the thickness of masonry walls that were well bonded. They were also able to determine the depth-of-cover over beams and girders and brick arches, and the location of voids, pipes and flues in walls up to 2 feet 8 inches thick (see figure 3).

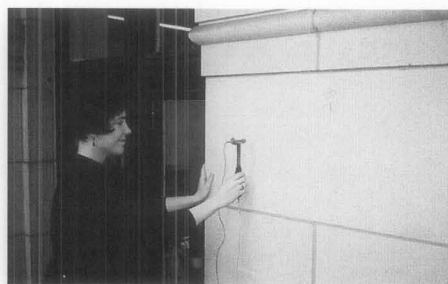
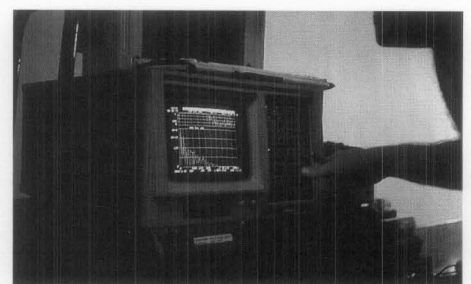
Figure 4. (left) The impact echo equipment includes a hammer, receiver, and water soluble coupling gel and was used to locate a steel column concealed behind the granite facing. Photo: Dennis Sack. (right) Impact echo data is shown on the field computer screen. Photo: Marie Ennis, P.E.

Impact Echo. Impact echo produced good data for reading wall thicknesses and the integrity of granite and sandstone columns, veneer walls, and brick walls less than two feet thick (see figure 4). While steel columns behind granite facing were located, the orientation of flanges was not discernible. The impact echo test provided excellent results in detecting stone cracking parallel to the surface. Its optimal use was when working with homogenous stone materials; with multiple layers of material (example: terrazzo over brick) it did not pro-

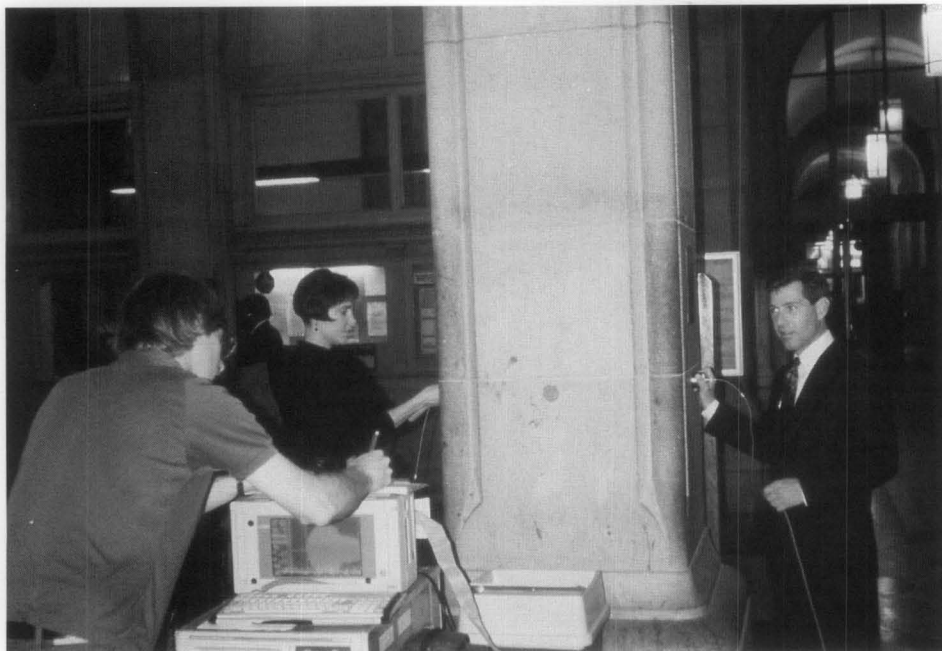
Fig. 5. Ultrasonic pulse velocity is being used to obtain characteristic wave velocities for granite. A transmitter is placed on one side of the column and a receiver on the opposite side. Photo: Andrea Lazarski.

Ultrasonic Pulse Velocity. Ultrasonic pulse velocity proved to be an excellent technique for determining the thicknesses and relative soundness of solid granite and sandstone columns (*see figure 5*). In composite walls, the velocity and signal strength dropped across mortar joints. Low frequency pulse velocity signals can provide good results for thick brick

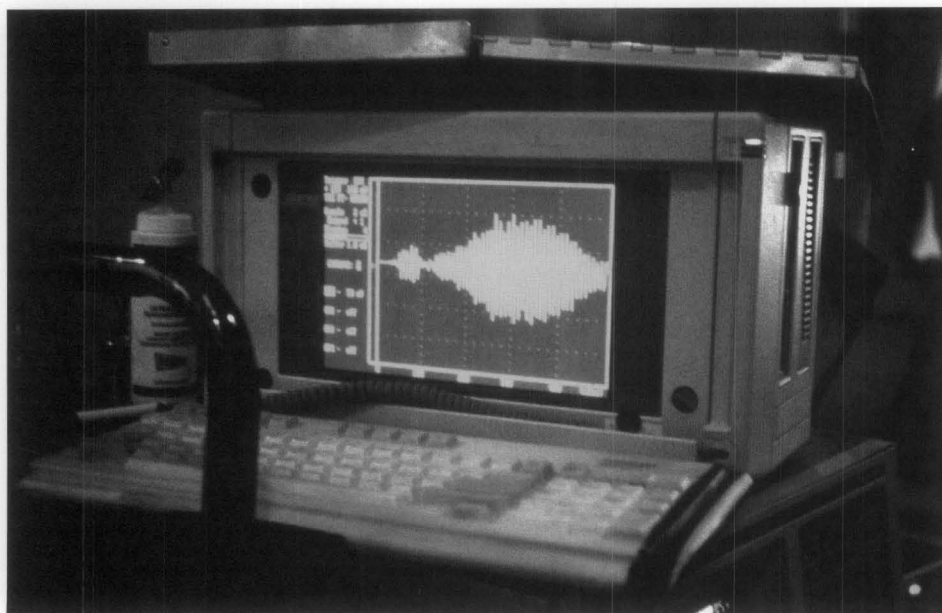
Fig. 6. Ultrasonic pulse velocity data is shown on the field computer screen. Photo: Marie Ennis, P.E.

walls where multiple mortar joints would otherwise block the transmission of higher frequency signals (*see figure 6*). A disadvantage of the low frequency energy is that the long wavelengths result in an "averaging" effect, which decreases the resolution of the method and does not allow for the location of smaller scale damage, such as brick unit de-bonding. In general, the results correlated well with the impact echo results. The two techniques should be used in conjunction; ultrasonic pulse velocity provides characteristic wave velocity

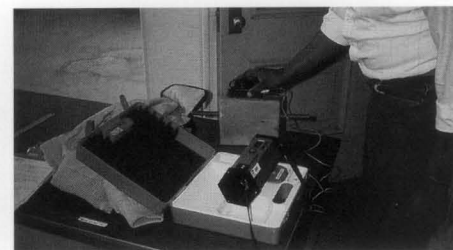
Fig. 7. This electromagnetic detection instrument is designed to locate rebars in concrete for quality control inspections. The diameter of the bar and the depth-of-cover is calculated and digitally displayed. Photo: Marie Ennis, P.E.

Electromagnetic Detection. This imaging technique worked well at locating iron beams and girders supporting brick arches that had as much as 9 inches of cover, provided no wire mesh existed (*see figure 7*). It was also successful at locating steel columns behind up to 8 inches of granite, and locating iron anchors in stone walls. Where wire mesh exists, such as in flat concrete slabs, the results were inconsistent.

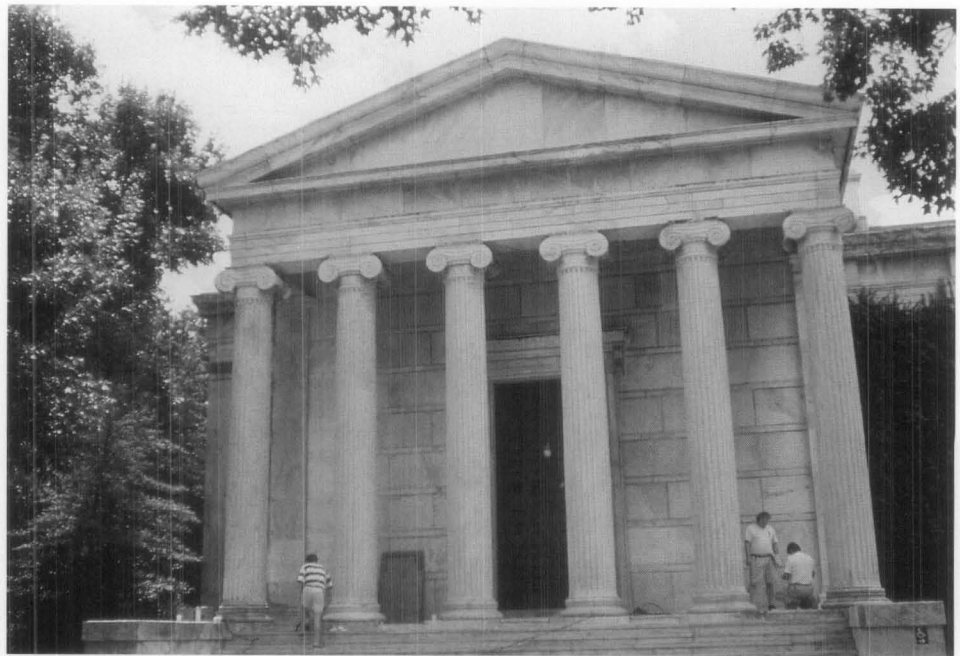
Fig 8. At Princeton University's Whig Hall, almost 100 years of weathering and a fire caused extensive damage to the masonry portico. Originally targeted for replacement, non-destructive testing techniques allowed isolated areas of damage to be evaluated and localized repairs conducted. Photo: Edmund P. Meade, P.E.

The portico of Whig Hall is primarily constructed of unreinforced, load bearing masonry. Weathering over the past 100 years and a major fire resulted in extensive cracking of the column bases and plinths; sugaring, erosion and pitting of marble surfaces; and erosion of mortar joints. Although initial reports commissioned by the university concluded that the portico substructure and columns should be replaced, less intrusive methods of repair were sought.

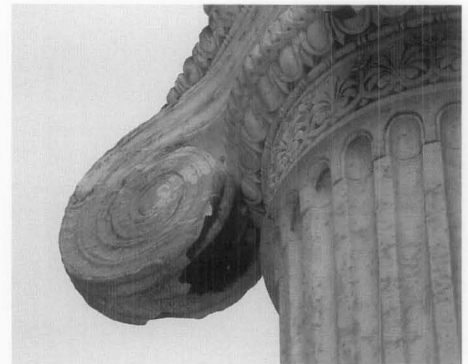
Fig. 9. The column capital volutes were cracked and spalled. Photo: Edmund P. Meade, P.E.

Initial condition investigations of the stone elements and the supporting structural members of the portico included a visual examination as part of the survey of the entire exterior of the building. All major elements were examined using "cherry pickers," scaffolding, and ladders. The examination focused on the cracked pieces of stone at the entablature level; the cracked or spalled column capital volutes; the cracked stone columns; the cracked stone column bases and plinths; the deteriorated pieces of masonry that were immediately below or adjacent to the column plinths; and the deteriorated support structure below the portico floors (*see figure 9*).

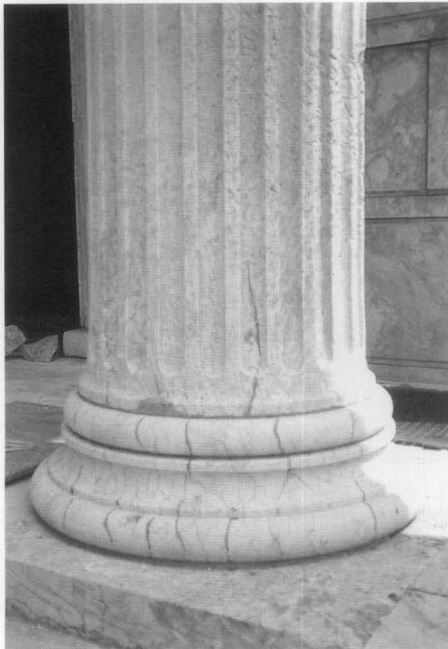
Fig. 10. The column base and plinths had extensive exterior cracks. The internal column cracks were detected by ultrasonic pulse velocity and impulse radar investigation techniques. Photo: Edmund P. Meade, P.E.

At Whig Hall, Column A exhibited severe surface cracking, and an extensive internal crack pattern within the plinths

(see figure 10). Additional cracking was noted at the bases of a number of other column shafts. Some deterioration of the masonry walls beneath the column plinths was also observed, although without signs of differential movement between different portions of the portico foundations.

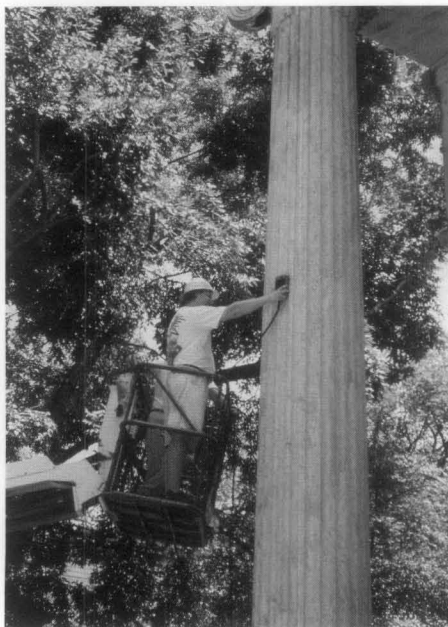
Fig. 11. Impulse radar is being used to evaluate both the orientation and depth of cracks visible on the surface of the column shaft. Photo: Edmund P. Meade, P.E.

Impulse Radar. The radar readings indicated that the column shafts were constructed of monolithic marble, with the same type of marble used for the column bases and capitals (see figure 12). The radar detected anomalies near the junctions of the column shaft with the base and the capital. The readings also indicated that there may be cramps or ties between the columns and the bases/capitals. It could not be determined whether the objects detected were metallic, or if they were possibly "Lewis holes" that had been used to maneuver the stone blocks during construction. Magnetic detection equipment with the ability to penetrate large diameter columns could have been used in conjunction with the radar to verify the nature of the internal anomalies.

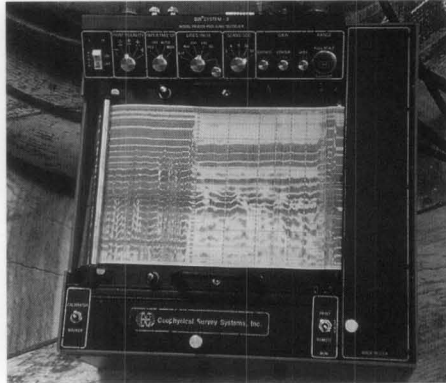
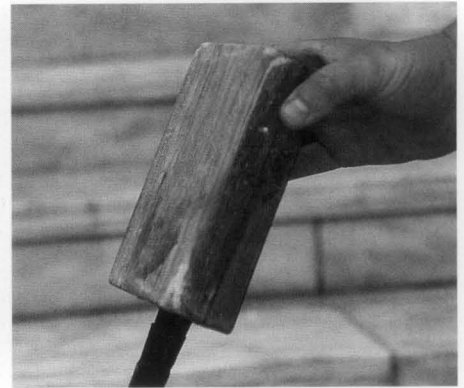
Fig. 12. (left) Raw radar output was analyzed by the geophysicists. Correlations could then be made to provide qualitative and quantitative evaluations of the stone. (right) This impulse radar transducer emits and receives electromagnetic energy. The unit is attached directly to the equipment shown at left. Photos: Edmund P. Meade, P.E.

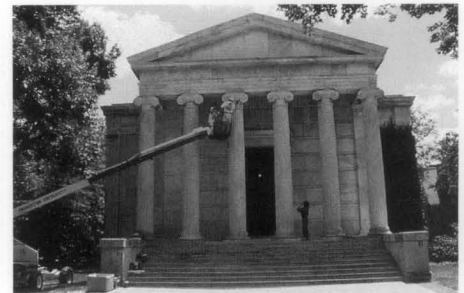
Fig. 13. The non-destructive evaluation of Whig Hall allowed the diagnosis of the condition of the masonry and the specification of a relatively low impact repair. Photo: Edmund P. Meade, P.E.

To help maintain the integrity of the masonry during the repairs, it was recommended that Column A, as well as several areas of other stone elements be pinned. It was necessary to support the column shafts while the bases and plinths were removed. This could be accomplished by the use of high strength steel pins through the column shaft, or the placement of steel clamps around the column shaft to establish a friction hold around the column.
