The Preservation of Historic Barns

Preservation Briefs

20

Michael J. Auer

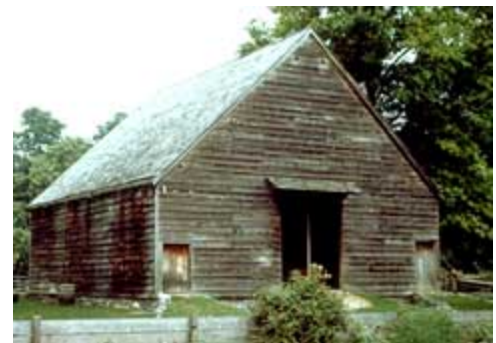
A gable roof, center wagon doors with pent roof, stock door at the corners, and horizontal clapboarding are all typical features of the Dutch barn.

Dutch Barns

The first great barns built in this country were those of the Dutch settlers of the Hudson, Mohawk, and Schoharie valleys in New York State and scattered sections of New Jersey.⁽²⁾ On the exterior, the most notable feature of the Dutch barn is the broad gable roof, which in early examples (now extremely rare), extended very low to the ground.

On the narrow end the Dutch barn features center doors for wagons and a door to the stock aisles on one or both of the side ends. A pent roof (or pentice) over the center doors gave some slight protection from the elements. The siding is typically horizontal, the detailing simple. Few openings other than doors and traditional holes for martins puncture the external walls.⁽³⁾ The appearance is of massiveness and simplicity, with the result that Dutch barns seem larger than they actually are.

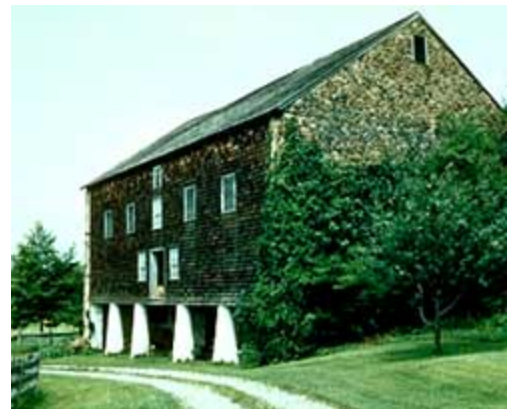
A gently sloping roadbed shows the "bank," from which bank barns get their name. Photo: NPS files.

The bank barn gets its name from a simple but clever construction technique: the barn is built into the side of a hill, thus permitting two levels to be entered from the ground. The lower level housed animals, the upper levels served as threshing floor and storage. The hillside entrance gave easy access to wagons bearing wheat or hay. (Fodder could also be

dropped through openings in the floor to the stabling floor below.) The general form of the bank barn remained the same whether it was built into a hillside or not. Where a hill was lacking, a "bank" was often created by building up an earthen ramp to the second level.

Bank barns were ordinarily constructed with their long side, or axis, parallel to the hill, and on the south side of it. This placement gave animals a sunny spot in which to gather during the winter. To take further advantage of the protection its location afforded, the second floor was extended, or cantilevered, over the first. The overhang sheltered animals from inclement weather. The extended forebay thus created is one of the most characteristic features of these barns. In some bank barns, the projecting beams were not large enough to bear the entire weight of the barn above. In these cases, columns or posts were added beneath the overhang for structural support.

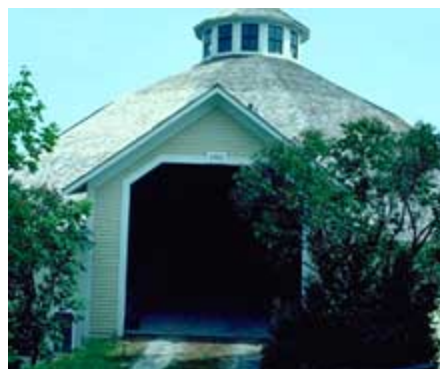
Circular barns are found throughout the country. This round barn, dated 1910, is in Vermont. It is 80 feet in diameter. Photo: Jay White.

Round barns were promoted for a number of reasons. The circular form has a greater volume-to-surface ratio than the rectangular or square form. For any given size, therefore, a circular building will use fewer materials than other shapes, thus saving on material costs. Such barns also offer greater structural stability than rectangular barns. And because they can be built with self-supporting roofs, their interiors can remain free of structural supporting elements, thereby providing vast storage capabilities. The circular interior layout was also seen as more efficient, since the farmer could work in a continuous direction.

In general, multi-sided barns—frequently of 12 or 16 sides—are earlier than "true round" barns. Earlier examples also tend to be wood sided, while later ones tend to be brick or glazed tile. Interior layouts also underwent an evolution. Early round barns placed cattle stanchions on the first floor, with the full volume of the floor above used for hay storage. In later barns, the central space rose from the ground floor through the entire building. Cattle stanchions arranged around a circular manger occupied the lower level; the circular wagon drive on the level above permitted hay to be unloaded into the central mow as the wagon drove around the perimeter. In the last stage of round barn development, a center silo was added when silos became regular features on the farm (in the last decades of the nineteenth century). In some cases, the silo projected through the roof.

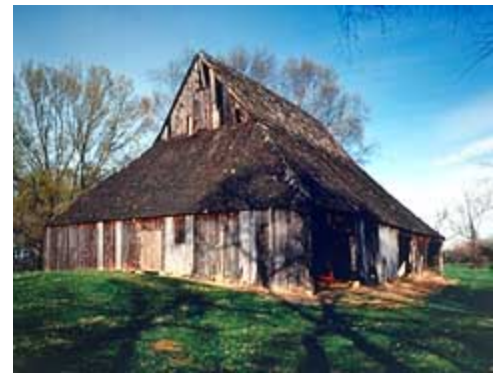
This 19th century tobacco barn, characterized by its steep gable-on-hip roof, is located in Prince Georges County, Maryland. Photo: Jack E. Boucher, NPS.

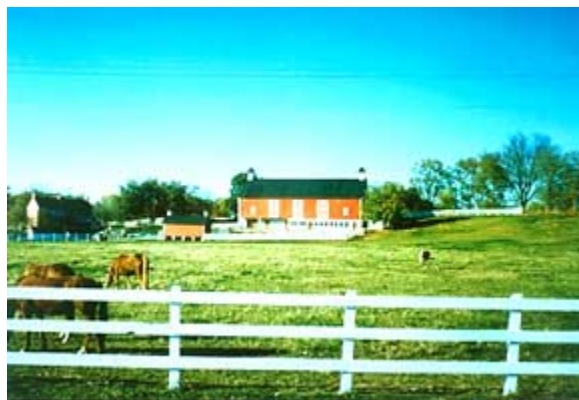
A barn is integral with its setting—orchards, ponds, fencing, streams, country roads, windmills, and silos. Photo: Jack E. Boucher, HABS Collection, NPS.

Setting is one of the primary factors contributing to the historic character of a barn. Farmers built barns in order to help them work the land; barns belong on farms, where they can be seen in relation to the surrounding fields and other structures in the farm complex. A barn crowded by suburbs is not a barn in the same sense as is a barn clustered with other farm buildings, or standing alone against a backdrop of cornfields. Hence, the preservation of barns should not be divorced from the preservation of the setting: farms and farmland, ranches and range, orchards, ponds, fields, streams and country roads.

Other important elements of setting include fences, stone walls, roads, paths, barnyards, corrals, and ancillary structures such as windmills and silos. (Silos, indeed, have become so closely associated with barns as nearly to have lost their "separate" identities.) These features help place the building in the larger agricultural context, relating it to its purpose in the overall rural setting.

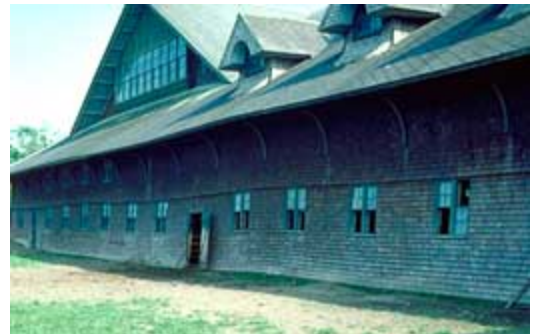
This enormous late 19th century barn in Shelburne, Vermont, displays a complexity and sophistication of roofing elements. See interior, below. Photo: NPS files.

The roof is among the most important elements of building form. Barns are no exception. The gable roof on Dutch and Prairie barns, the cone-shaped, dome-shaped, eight or twelve-sided roof of round barns, and the gambrel roof of the "typical" barn are among the most prominent features on these buildings. A barn roof can often be seen from a distance, and for this reason must be considered a major feature.

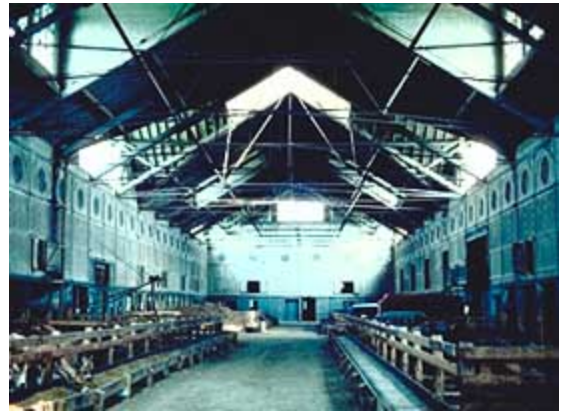
The interior of the barn in Shelburne, Vermont, is a magnificent space that included an overhead hay loft with tracks that allowed workers to drop hay to the floor below. Photo: NPS files.

The impression received upon stepping into many historic barns is that of space. Not infrequently, the entire building appears as a single large space. To enter these buildings is sometimes to experience the entire expanse of the building at once. Even when haylofts and animal stalls "consume" part of the building, they often do not keep the full expanse of the interior from being seen.

In large barns, this can be an imposing sight. More commonly, the barn is a combination of confined spaces on the lower floor and a large open space above; in this case, the contrast between the confined and open spaces is also striking. The openness of the interior, furthermore, often contrasts with the "blankness" typical of many barn exteriors, with their relatively few openings.

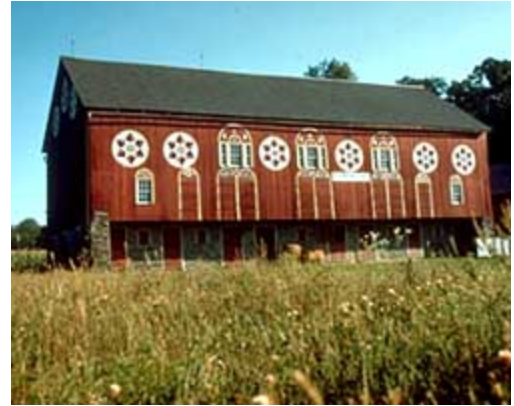
Hex signs are among the wide range of decorative elements found on American barns. Photo: NPS files.

Historic barns, like modern ones, are structures built for use. Nevertheless, decorative elements are not lacking on barns. Foremost among these is color (red being most common). Dutch barns traditionally sported distinctively shaped martin holes in the upper reaches of the building. Traditional hex signs on Pennsylvania barns are so well known as to have entered the mainstream of popular culture and taken on a life of their own. Decorative paint schemes, including contrasting colors to "pick out" cross members of the external framework, are common (these most frequently take the form of diamonds or "X's" on the main doors). Sign painters often took advantage of the size and visibility of barns in an age before billboards. "Mail Pouch Tobacco" signs were nearly as numerous in the first quarter of the 20th century as patent medicine ads were in the last quarter of the 19th. Another decorative motif on historic barns is the arrangement of spacings between bricks to form decorative patterns (as well as to ventilate the barn).

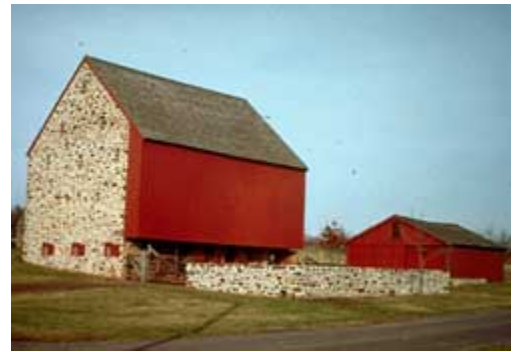
This well-maintained late 18th century barn is located in Worcester, Pennsylvania. Note the use of indigenous stone in the structure and surrounding fencing. Photo: Robert McCullough.

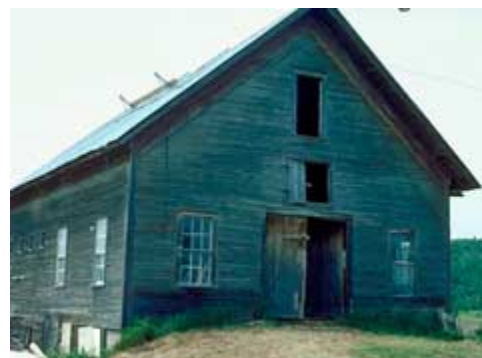
This horse barn, ca. 1875, is in Stowe, Vermont. Its cupola has been removed for repair. Photo: NPS files.

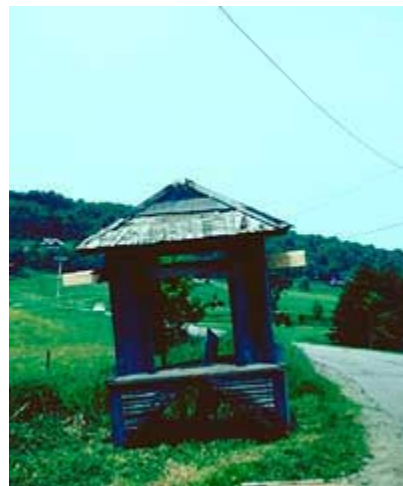
This cupola will be repaired and returned to the horse barn roof (see photo, above). Photo: NPS files.

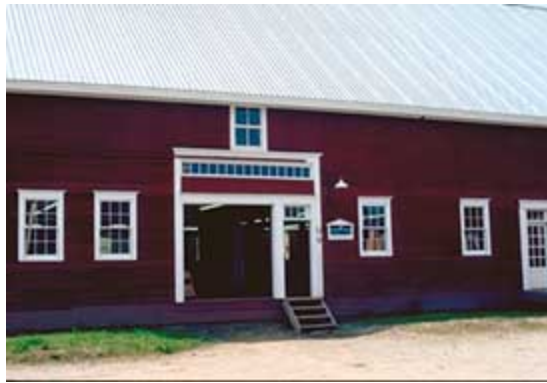
This historic barn was successfully converted into a furniture factory. Photo: NPS files.
