## Early 20th-Century Building Materials: Resilient Flooring

*Richa Wilson, Intermountain Regional Architectural Historian  
Kathleen Snodgrass, Project Leader*

This tech tip is the third in a series about innovative building materials developed in the first half of the 20th century and commonly used in Forest Service buildings. The series will help you identify materials by describing their histories, manufacture, and physical characteristics. It will also address common problems and provide guidance on maintenance, repair, and replacement.

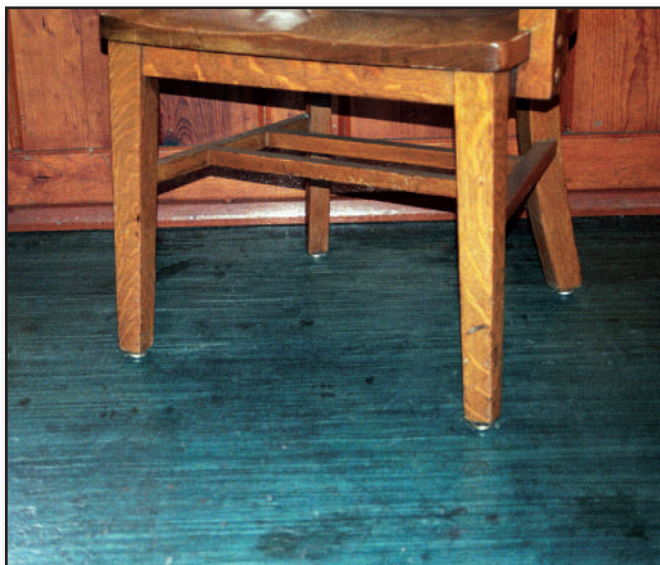
Figure 1—This jaspé pattern flooring has many dents and stains from years of use in the cookhouse at the Fenn Ranger Station (Nez Perce National Forest, Northern Region), but it is still serviceable.

Jaspé and marbled patterns were more decorative than plain linoleum. They were characterized by streaks of color running in one direction (jaspé, figure 1) or with no distinguishable direction (marbled, figure 2).

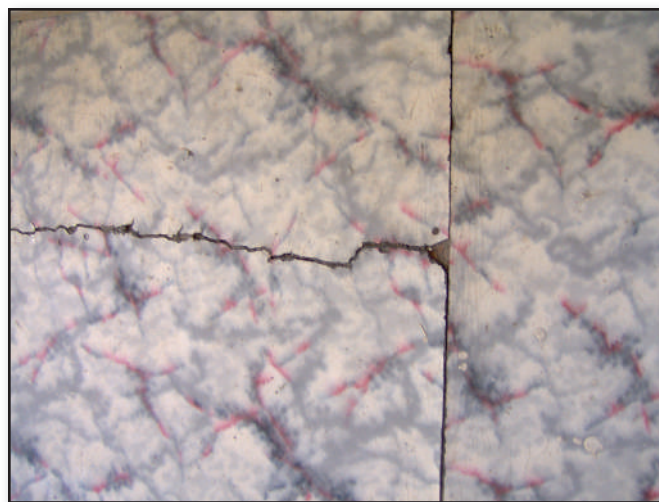
Figure 2—This marbled pattern linoleum flooring has developed cracks. Small nails secure the flooring to the subfloor.

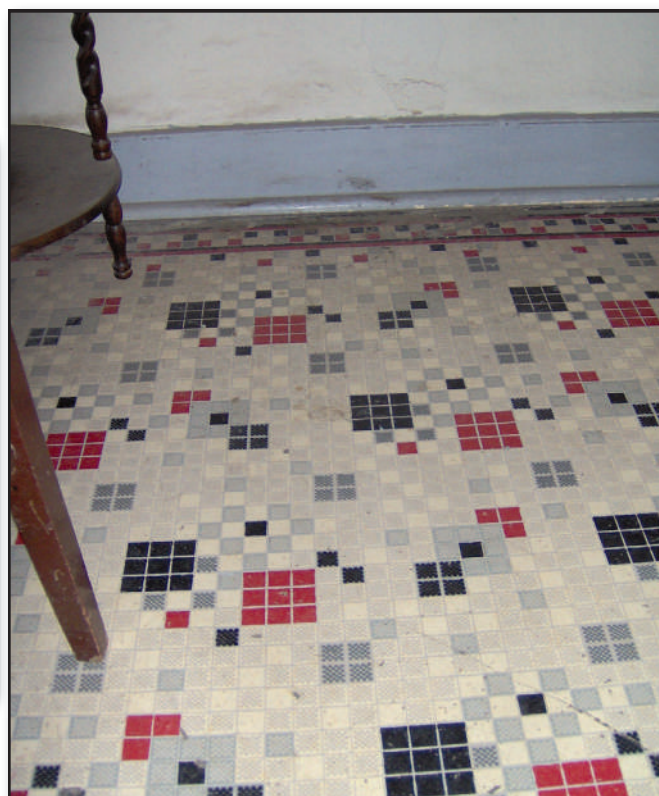
Figure 3—This linoleum flooring is holding up fairly well, but the printed pattern is scratched and worn.

Linoleum was often printed or inlaid with floral designs and geometric shapes, including patterns that imitated brick or stone. Printed linoleum, with its block-stamped patterns, could be quite intricate. However, the printed colors were susceptible to wear if they were not sealed regularly with wax (figure 3).

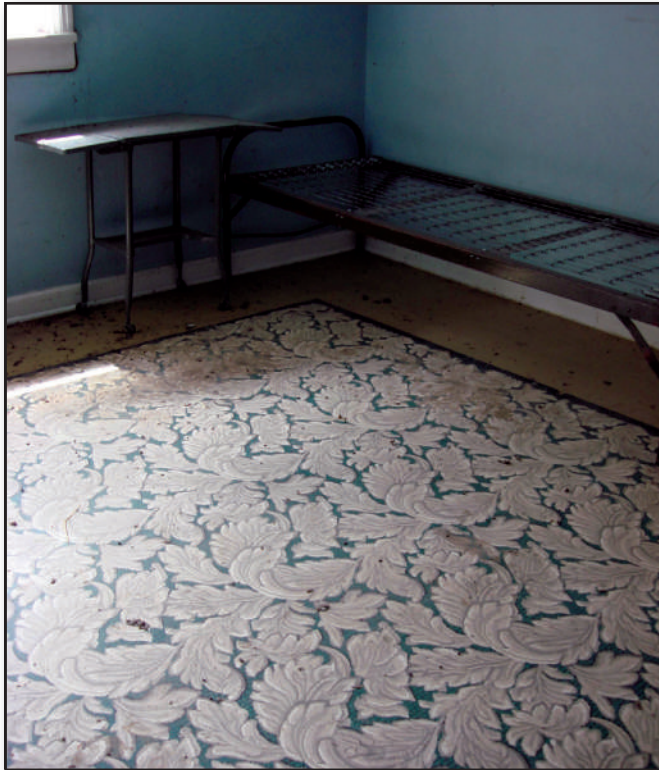
Figure 4—This intricately patterned, felt-base Congoleum “rug” protects the middle of the painted softwood floor of a bedroom at the Warm River Hatchery (Ashton-Island Park Ranger District, Caribou-Targhee National Forest, Intermountain Region). The Congoleum is in very good shape. The floor is spotted with flies that accumulated over the winter and have not yet been swept from the seasonal-use building.

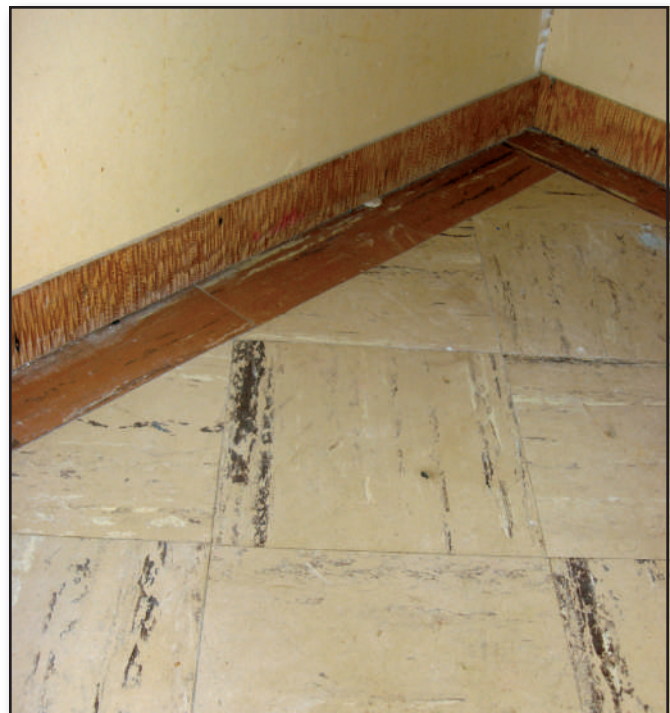
Figure 5—This asphalt tile flooring from 1951 has a darker band of tiles around the edge of the room for contrast and a plywood baseboard that was painted to look like the flooring.

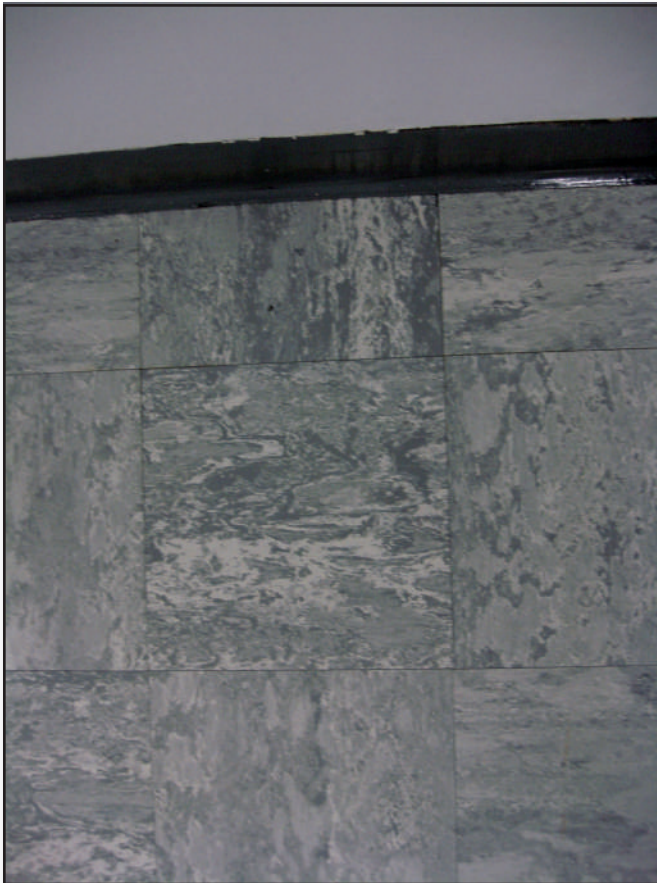
Figure 6—Although vinyl flooring can be manufactured in almost any pattern and color, this vinyl tile in the Intermountain Regional Office (Ogden, UT) is patterned to resemble gray-and-white marble.

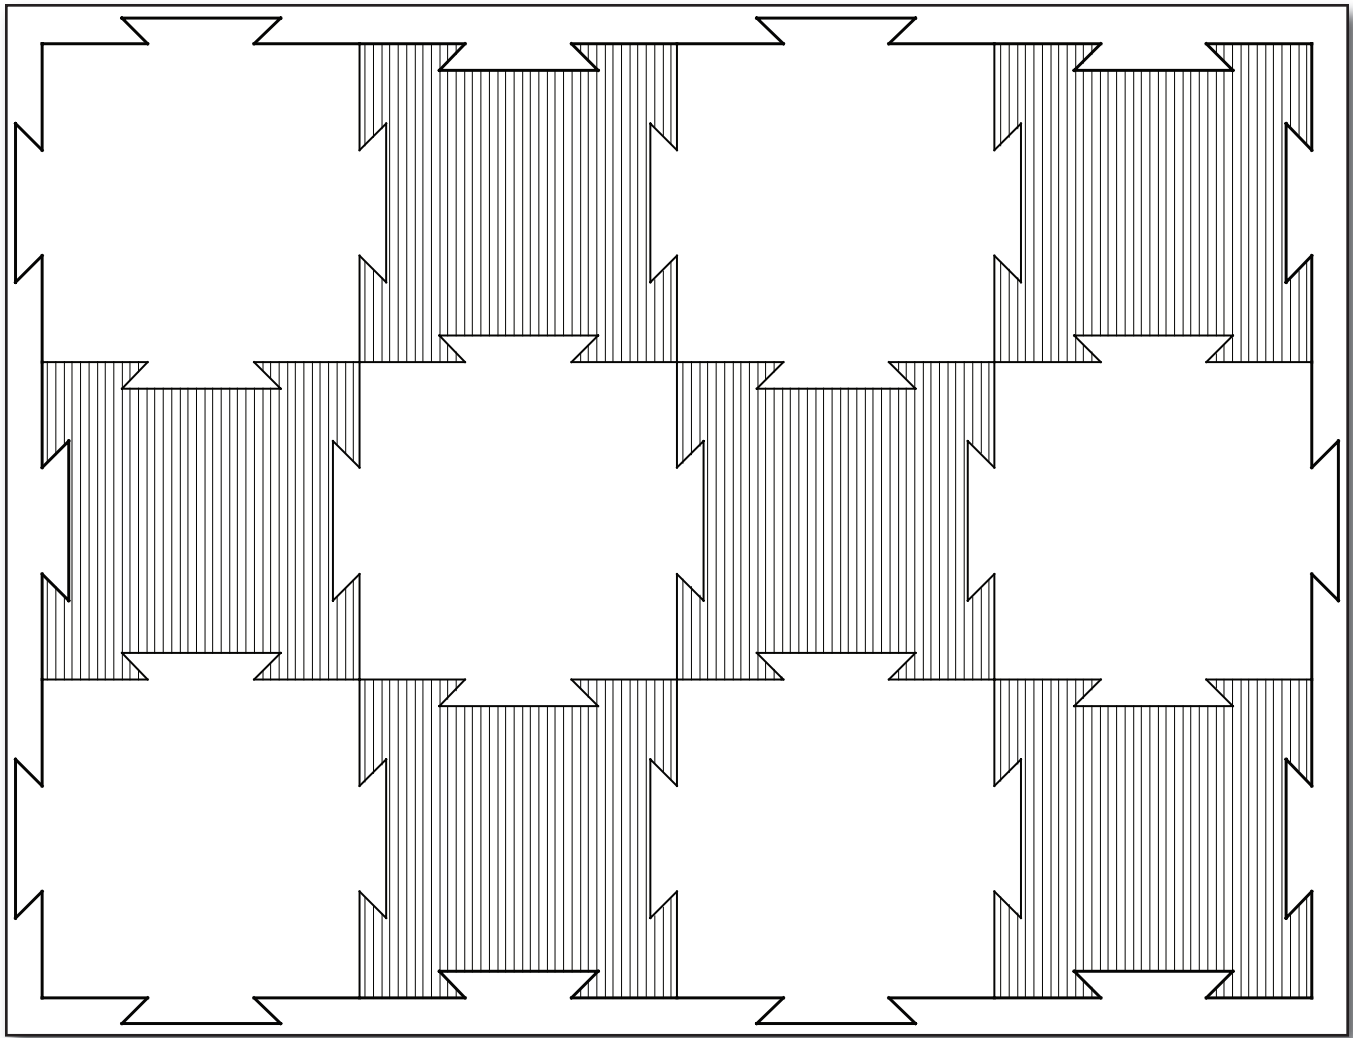
Figure 8—Rubber flooring used in the early 1900s consisted of small, interlocking tiles. The tile pattern shown in this drawing was patented in 1894 by Philadelphia architect Frank Furness.

Rubber flooring was manufactured in the mid-19th century, but its use became more common after 1894 when Philadelphia architect Frank Furness patented a system of small, interlocking rubber tiles (figure 8). By the early 20th century, several companies were producing similar tiles in square, rectangular, and triangular shapes. Tiles typically measured 2 inches square, and they could be assembled in creative, colorful mosaics. Larger tiles became available in many sizes and often were laid in checkerboard,
