[Home](#) > [How to Preserve](#) > [Preservation Briefs](#) > 21 Flat Plaster

## PRESERVATION BRIEFS

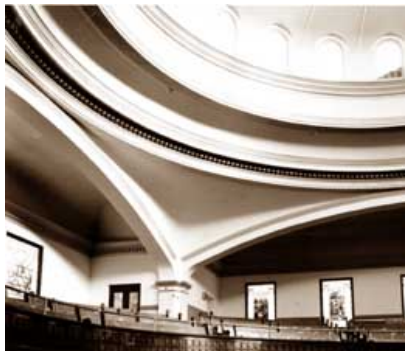
Plaster was used as the interior surface coating of this elegant 1911 church located in Eugene, Oregon. Photo: NPS files.

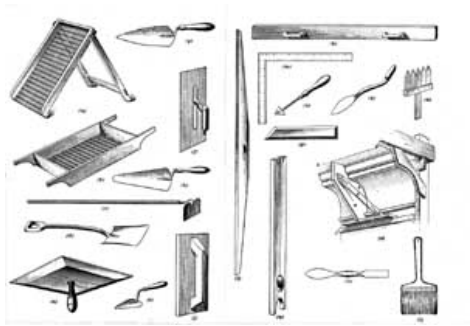
Many of these traditional plastering tools are still used today. Drawing: NPS files.

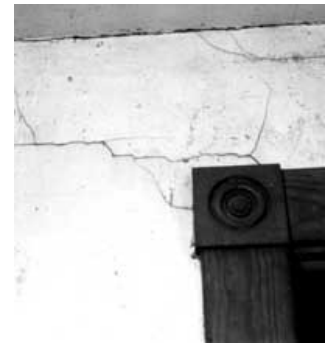
Stress cracks in plaster over a kitchen door frame can be repaired using fiberglass mesh tape and joint compound. Photo: NPS files.

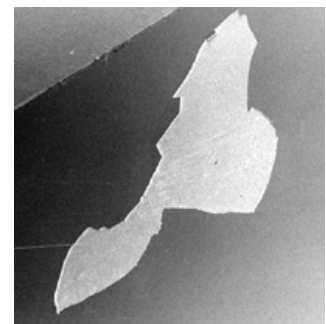
The smooth-trowled lime finish has delaminated from the brown coat underneath. Photo: Marylee MacDonald.

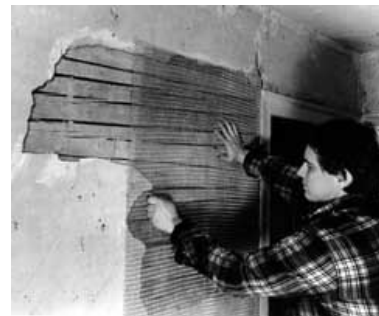
In this New Hampshire residence dating from the 1790s, the original plaster was a single coat of lime, sand, and horsehair applied over split lath. A one-coat repair, in this case, is appropriate. Photo: John Leeke.

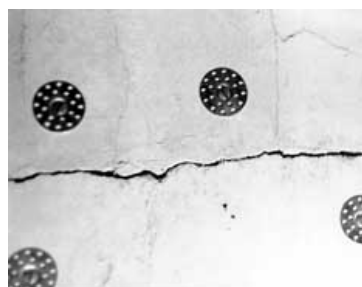
Flat-head wood screws and plaster washers were used to reattach loose ceiling plaster to the wood lath. After the crack is covered with fiberglass mesh tape, all will be skim-coated with a patching compound. Photo: John Obed Curtis.

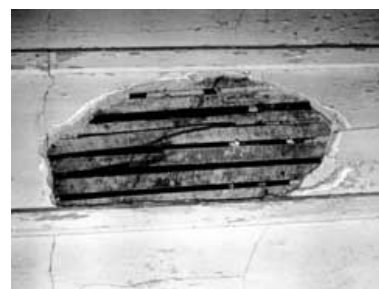
This beaded ceiling in one of the bedrooms of the 1847 Lockwood House, Harpers Ferry, West Virginia, is missing portions of plaster due to broken keys. Photo: NPS files.

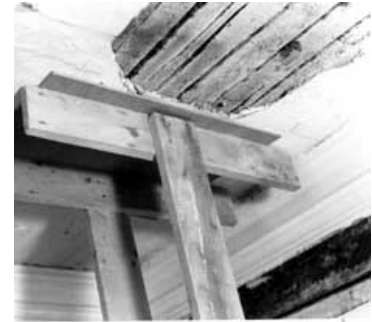
When ceiling repairs are made with wet plaster or with an injected adhesive mixture, the old loose plaster must be supported with a plywood brace until re-keying is complete. Photo: John Leeke.
